**FEDERAL AVIATION ADMINISTRATION
AIRWORTHINESS DIRECTIVES
LARGE AIRCRAFT**

BIWEEKLY 2003-18

BOEING AIRWORTHINESS DIRECTIVE LARGE AIRCRAFT

2003-16-16 Boeing: Amendment 39-13269. Docket 2002-NM-128-AD. Supersedes AD 2000-09-03, Amendment 39-11711.

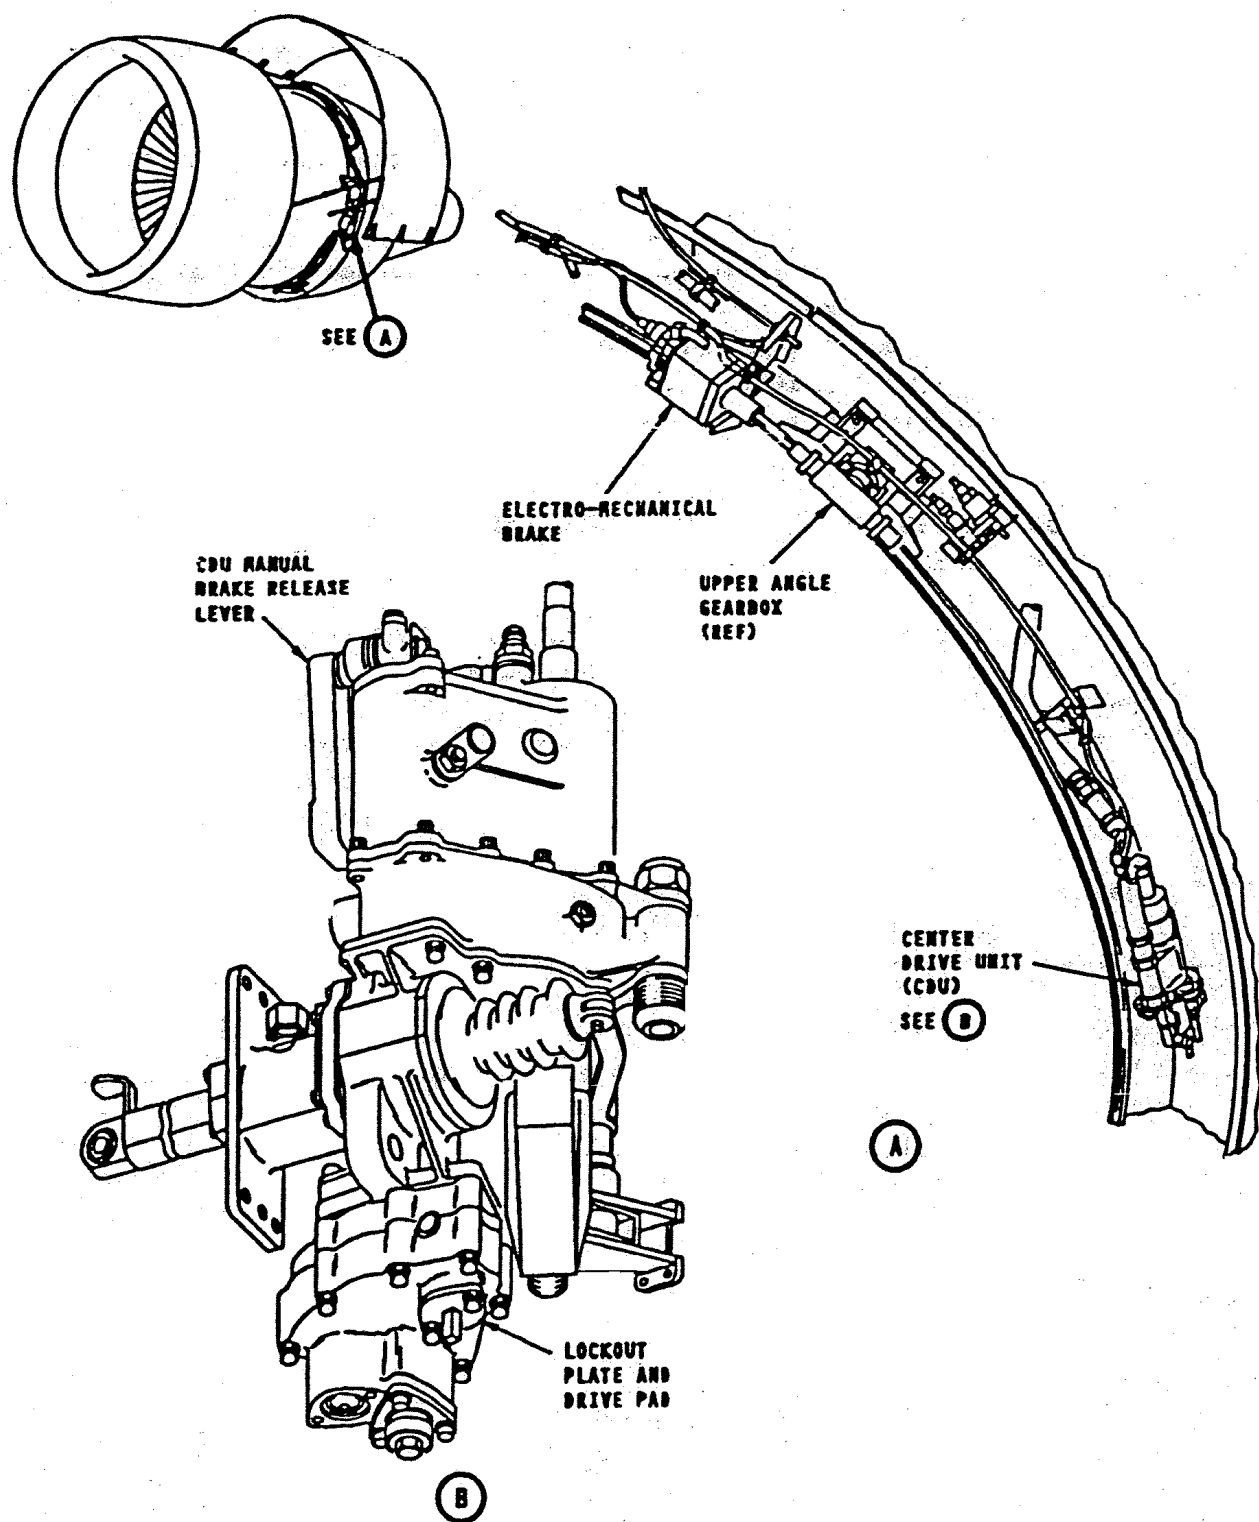
**Electro-Mechanical Brake and CDU Cone Brake Torque Check
Figure 1**

Caution: Do not use more than 100 pound-inches of torque when you do this check. Excessive torque will damage the CDU.

(8) If the torque is less than 15 pound-inches, you must replace the CDU.
